Acoustic Detection of Faults and Degradation in a High-Bypass Turbofan Engine During Vehicle Integrated Propulsion Research (VIPR) Phase III Testing

Devin K. Boyle

NASA Armstrong Flight Research Center

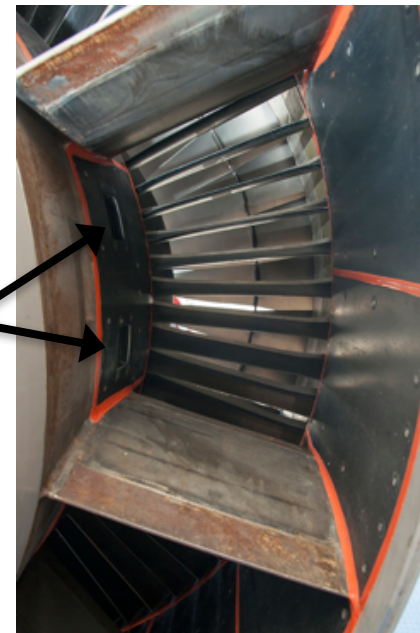
Research Engine (F117-PW-100)

14th Stage (HPC)

Station 2.5 (LPC Exit)

- $F_n \sim 40,000 \text{ lbf}$
- $BPR = 6$
